Citation: Qian, K., Lan, D., Zhang, L., Fu, F. & Fang, Q. (2022). Robustness of Post-Tensioned Concrete Beam-Column Sub-assemblies under Various Column Removal Scenarios. *Journal of Structural Engineering*, 148(5), doi: 10.1061/(ASCE)ST.1943-541X.0003324

Robustness of Post-Tensioned Concrete Beam-Column Sub-assemblies under Various Column Removal Scenarios

Kai Qian¹ M. ASCE, Dong-Qiu Lan², Lu Zhang³ M. ASCE, Feng Fu⁴ F. ASCE, Qin Fang⁵

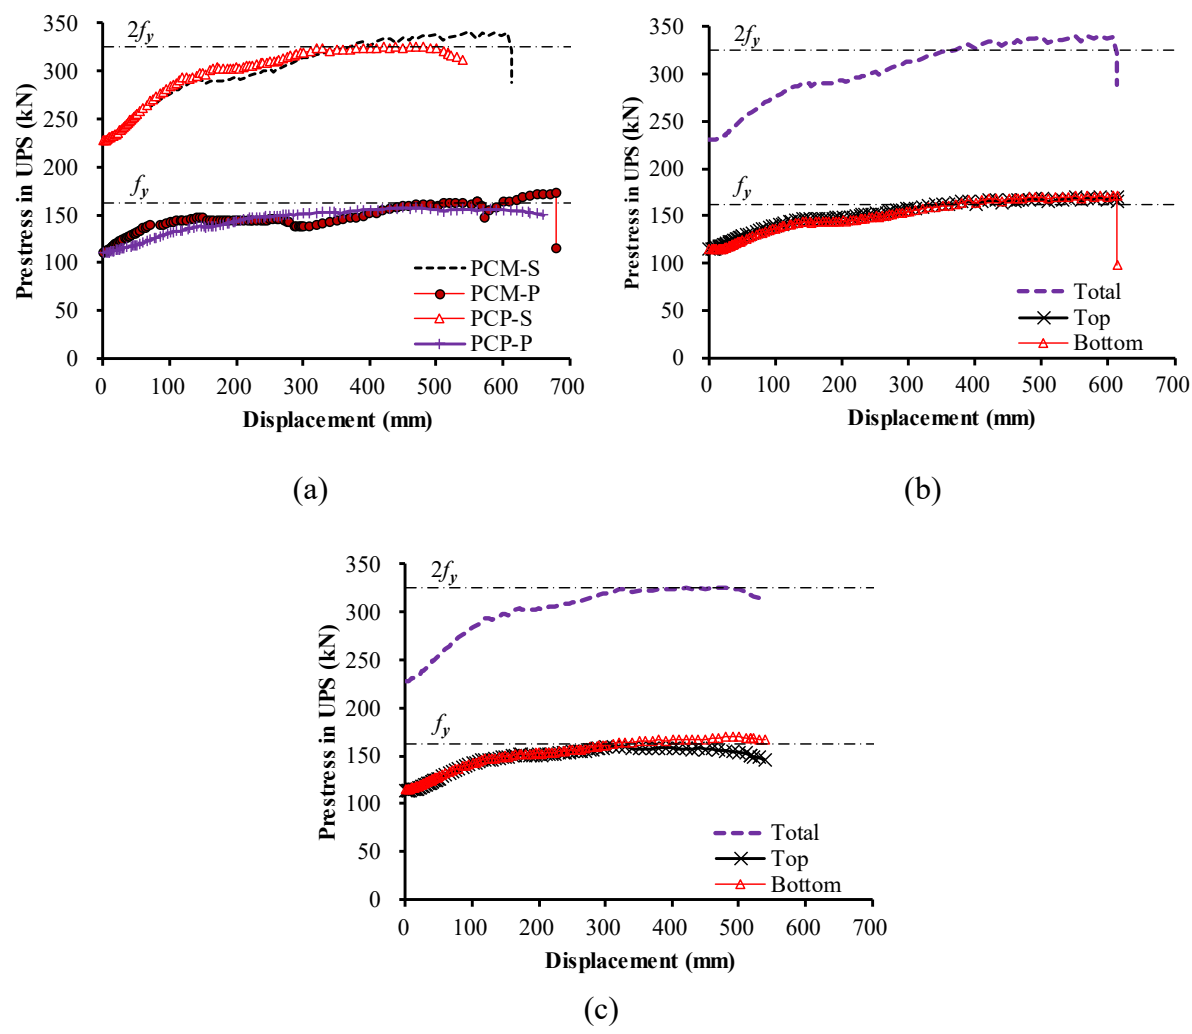
Fig. 15 illustrates the variation of the prestressing force of strands of the four specimens. As described in the previous section, the effective prestressing force of $0.65 f_{pu}$ (119 kN) was applied in each strand. However, due to the prestressing force loss, the effective prestressing force of PCM-S, PCP-S, PCM-P, and PCP-P was respectively measured as 230 kN, 228 kN, 111 kN, and 111kN, respectively, at the beginning of the test. As shown in Fig. 15a, the strand in PCM-P yielded at a RCD of 520 mm. However, the strand in PCP-P did not yield during the loading process, indicating that the strand was not fully utilized when the loss of a penultimate column was focused on. As shown in Figs. 15b and c, for PCM-S and PCP-S, the prestressing force of the bottom strand was similar to that of top strand. The bottom strand in PCM-S fractured at a RCD of 614 mm, and the maximum prestressing force was measured as 172 kN at this displacement. Moreover, it was found that the fracture of strand was observed before reaching its ultimate strength. This is because the strand was subjected to complex stress during the tests, rather than the pure tensile stress. In general, the fracture of strand occurred at the position with great stress concentration, such as the beam-column interfaces.

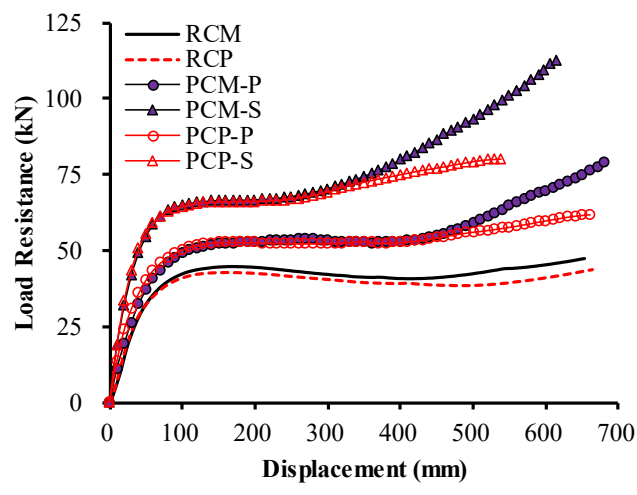
Fig. 16 illustrates the dynamic capacity curves of the specimens with and without UPS. The dynamic ultimate load of Specimen RCM, RCP, PCM-S, PCM-P, PCP-S, and PCP-P were 48 kN, 44 kN, 113 kN, 79 kN, 80 kN, and 62 kN, respectively. Thus, the straight and parabolic UPSs increased the ultimate dynamic load of RCM by 135% and 65%, respectively. Similarly, the straight and parabolic UPSs increased the dynamic ultimate load of RCP by 82% and 41%,

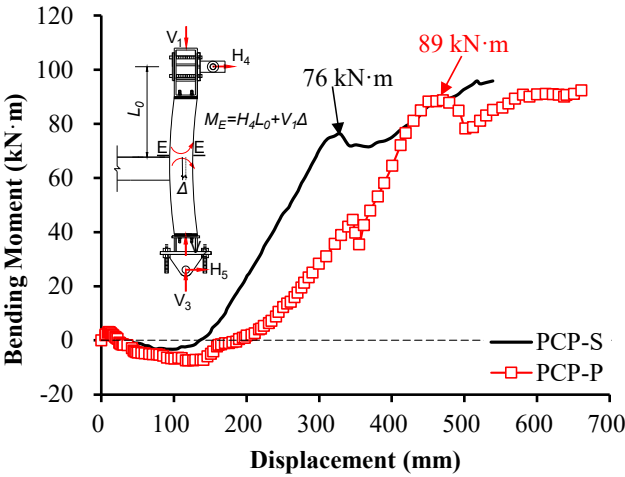
To better understand the failure mode of the right column, the bending moment of critical section E-E in the right column was determined by Eq. (2) and shown in Fig. 17.

Fig. 17 shows the variation of bending moment in right-side column of the PC frame under a penultimate column removal scenario while Fig. 18 presents the theoretical M-N curve of E-E section. As shown in Fig. 17, the bending moment at Section E-E was negative (clockwise direction) first and then converted to positive (counter-clockwise direction). When the RCD reached 329 mm, the bending moment of E-E section was 76 kN·m and then began to decrease. Theoretically, as shown in Fig. 18, the E-E section reached eccentric tension failure at this stage. However, the re-ascending behavior was observed for the bending moment. This is because the designed axial compression force in the side column was assumed to be constant in calculation, but actually it kept decreasing after damage in the side column. Similar observation was found in PCP-P.

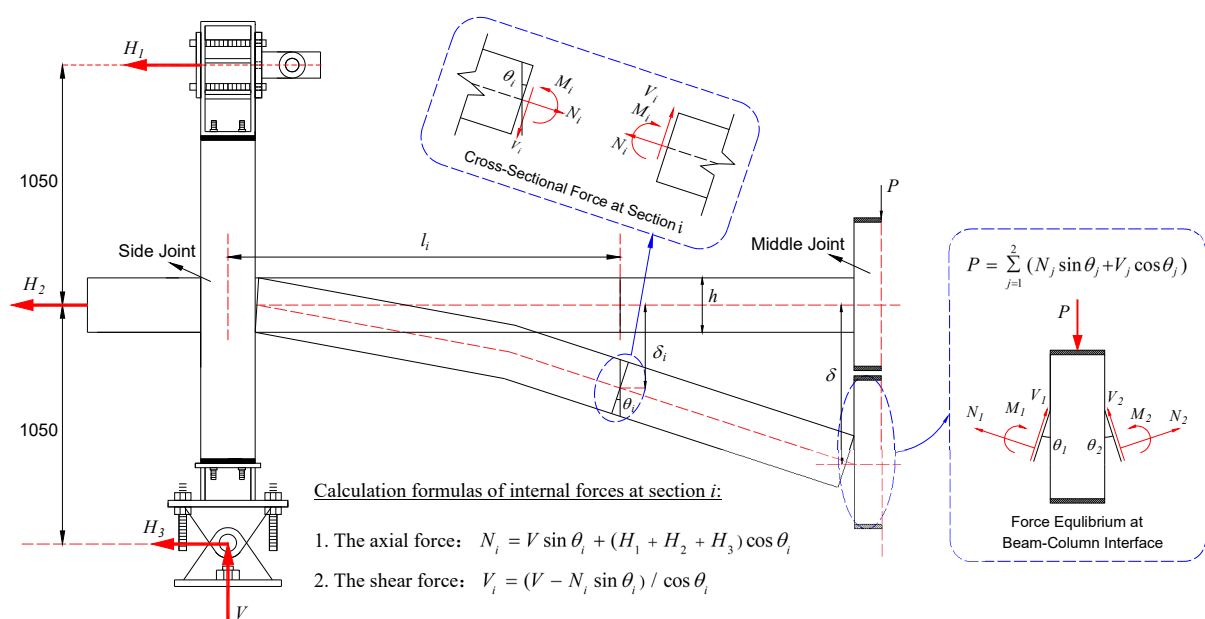
Fig. 19 illustrates the static equilibrium of a section of a deformed beam. As given in the figure, the vertical load resistance consists of the vertical component of axial force and shear force, which can be mathematically expressed by:

$$P = \sum_{j=1}^2 (N_j \sin \theta_j + V_j \cos \theta_j) \quad (3)$$

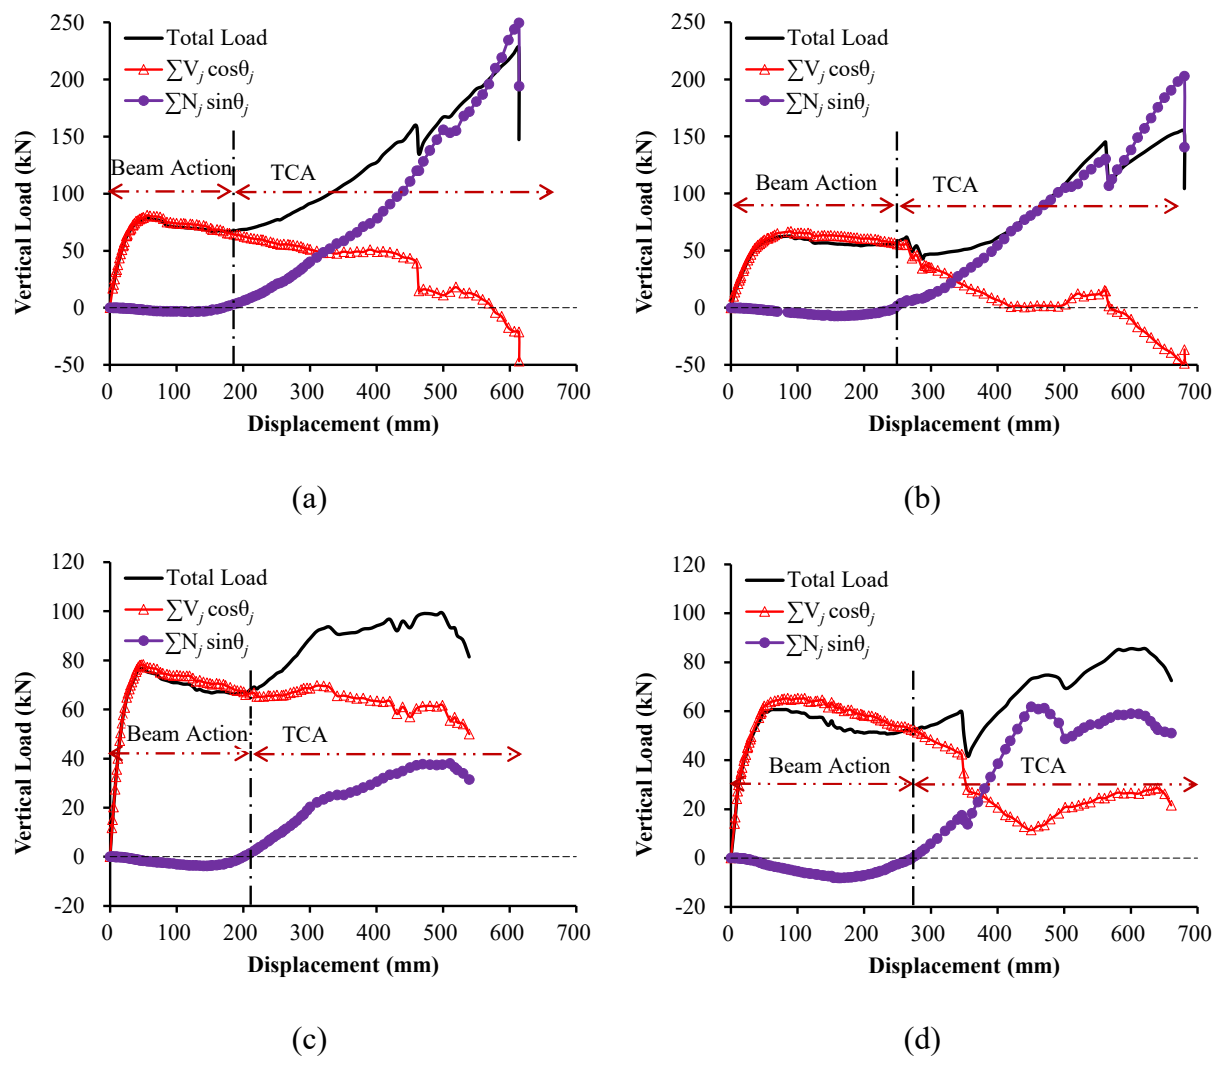
Fig. 20 shows the de-composition of the load resistance at the critical section (beam-removed column interface) of the PC specimens. All those PC specimens had similar load resistance component at the beginning of the test. At this stage, the shear force (bending moment) contributed majority of the load resistance, the axial force made negative but marginal contribution. At large deformation stage, the contribution from the shear force of PCM-S and PCM-P decreased quickly and even became negative at the end of the tests, while the axial force contributed majority of the load resistance. Thus, the TCA from strand was the main load-resisting mechanism at the large deformation stage. In comparison, the contribution from the shear force of PCP-S is always greater than that from the axial force, indicating that bending moment still actively developed in the BENM (no rebar fracture occurred). Regarding PCP-P, due to rebar fracture at the BENM, the contribution from the shear force was much lower compared with PCP-S.

In general, two major load-resisting mechanisms were found from the PC specimens to resist the applied load: beam action and TCA. The beam action can be further categorized as the flexural action and CAA depend on whether axial compressive force developed in the beams. Firstly, the beams deformed within elastic range without axial forces developed in the beams, the applied load was resisted by the bending of beam ends. Subsequently, the plastic hinges began to form in the beam ends due to increased deflection, while the axial compressive force began to develop in the beams because the beam ends prone to move outward but were constrained by boundary. With the help of the induced axial compressive forces, the bending moment capacity of the beam ends exceeded yield bending moment. This is the so call “CAA”. Therefore, the enhancement of the flexural capacity due to CAA was inherently attributed to additional plastic moment caused by the axial compressive forces in the beams. When the beams undergo the deformation of approximate
